Monitoring Completed Navigation Projects Program

Inspections of Previously Monitored Rubble-Mound Coastal Structures

Robert R. Bottin, Jr., Larry R. Tolliver, and
Glenn B. Myrick

September 2004

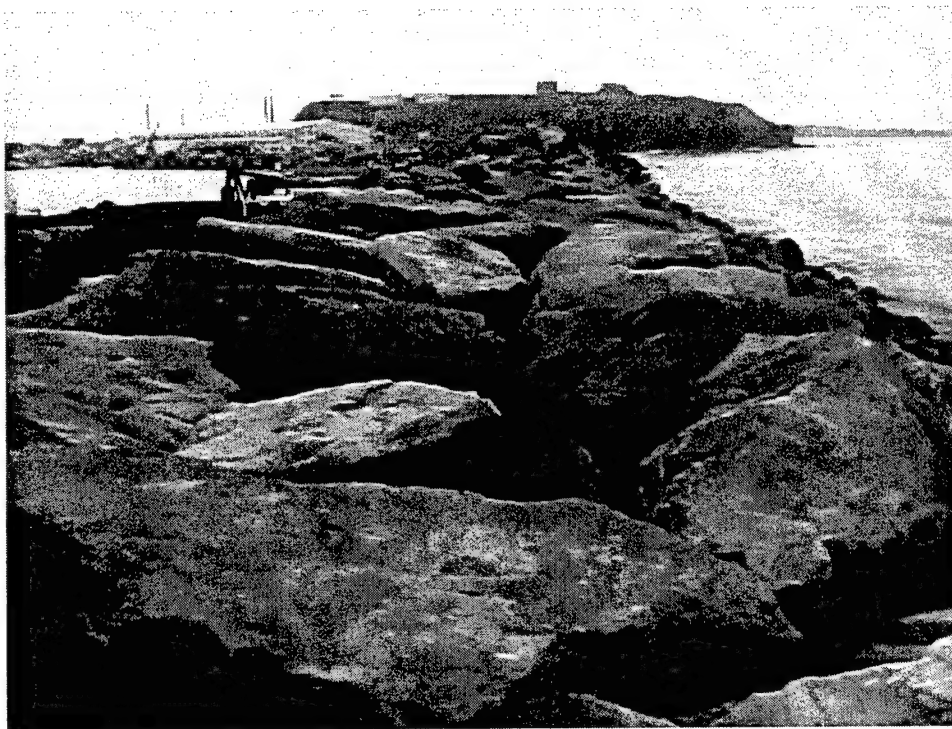
The most recent walking inspection of the St. Paul Harbor main breakwater (Figure 3) was conducted on 17 June 2003. Although isolated subsidence and voids were noted in areas of the breakwater, comparisons with the latest breakwater topography confirmed that these areas existed in 2000. The inspection indicated little visual change in the structure el. However, further deterioration of some of the broken/cracked armor stones was observed. Overall the breakwater was in good condition. Seaward of the breakwater, it was noted that kelp had attached to the reef breakwaters and was growing vertically almost to the water surface.

Figure 3. View of St. Paul Harbor main breakwater

- a. Inspection of the St. Paul Harbor main breakwater, AK, revealed subsidence and voids in isolated areas of the structure. When compared to the previous survey data of 2000, however, little change was noted in breakwater elevation. Further deterioration of some of the broken/cracked armor stones previously identified was observed. Overall, the breakwater was in good condition. It should be inspected annually due to the extreme wave and ice climate to which it is subjected.

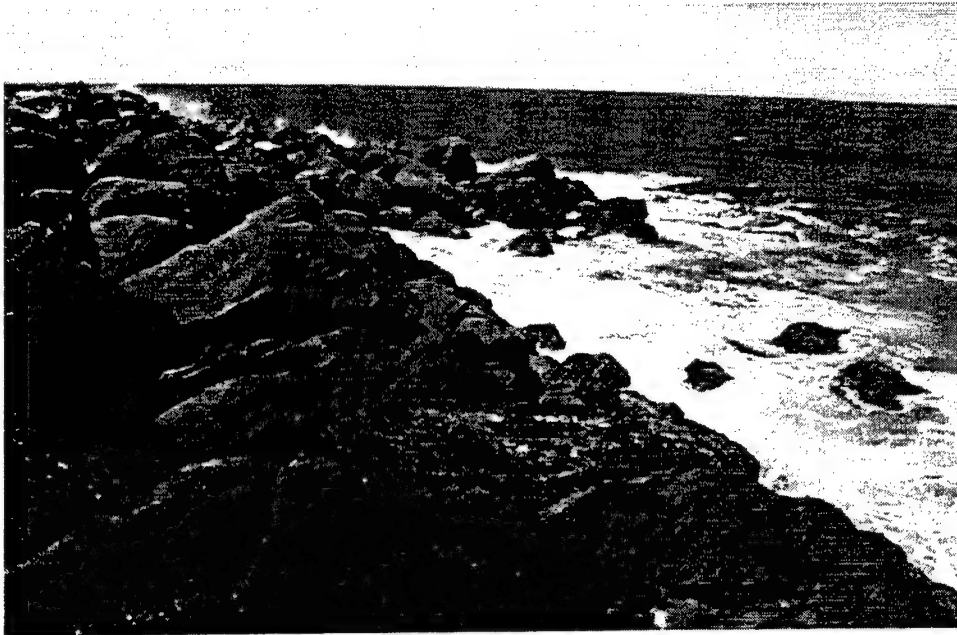
Figure 5. Head of Yaquina Bay north jetty on 24 June 1997

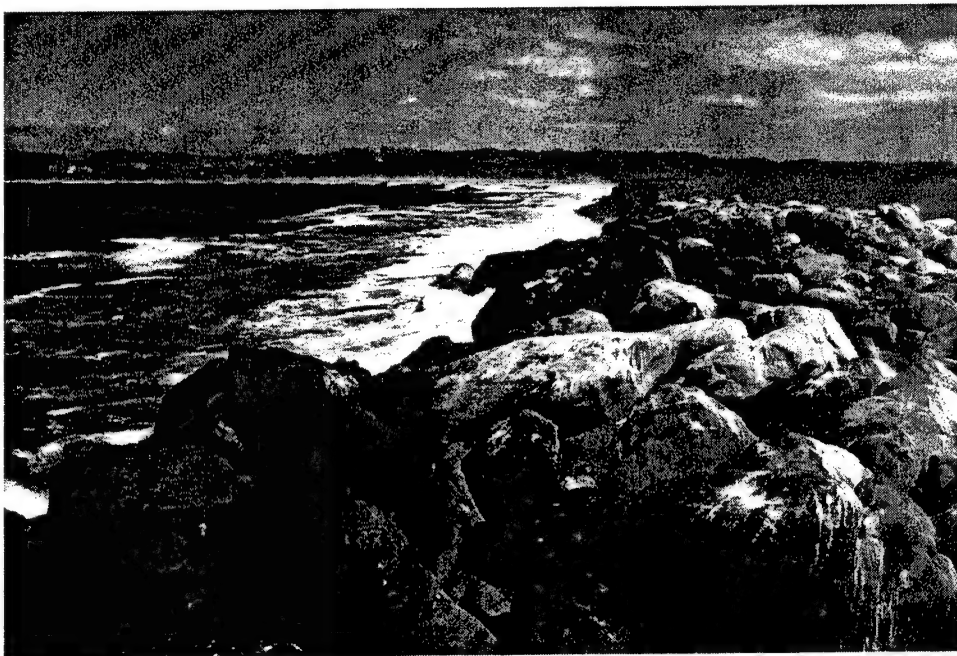
The most recent walking inspection of the Yaquina north jetty was conducted on 27 August 03. The head of the jetty was in excellent condition. The trunk of the structure was similar to that observed in 1997. Subsidence was observed in areas along the crest on the seaward portion of the jetty. Voids observed previously (Figures 6 and 7) appeared to be similar in appearance, and there were other sporadic areas along the crest that could use armor stone to bring the jetty back to its design cross section. Overall, the structure was in good condition.

Figure 6. Voids on seaward side of Yaquina north jetty

- b. Inspection of the Yaquina Bay north jetty, OR, revealed some low areas in the crest and some voids on the slopes of the jetty. These observations were also noted in the previous inspection of 1997. The head of the structure, rehabilitated in 2001, was in excellent condition. Consideration should be given to placing armor stones in the voids of the structure trunk during scheduled maintenance to prevent future major damage, and in areas along the structure crest to bring the jetty back to its design cross section. The trunk of the jetty is in good condition overall. The structure should be inspected periodically, particularly after major storm events.

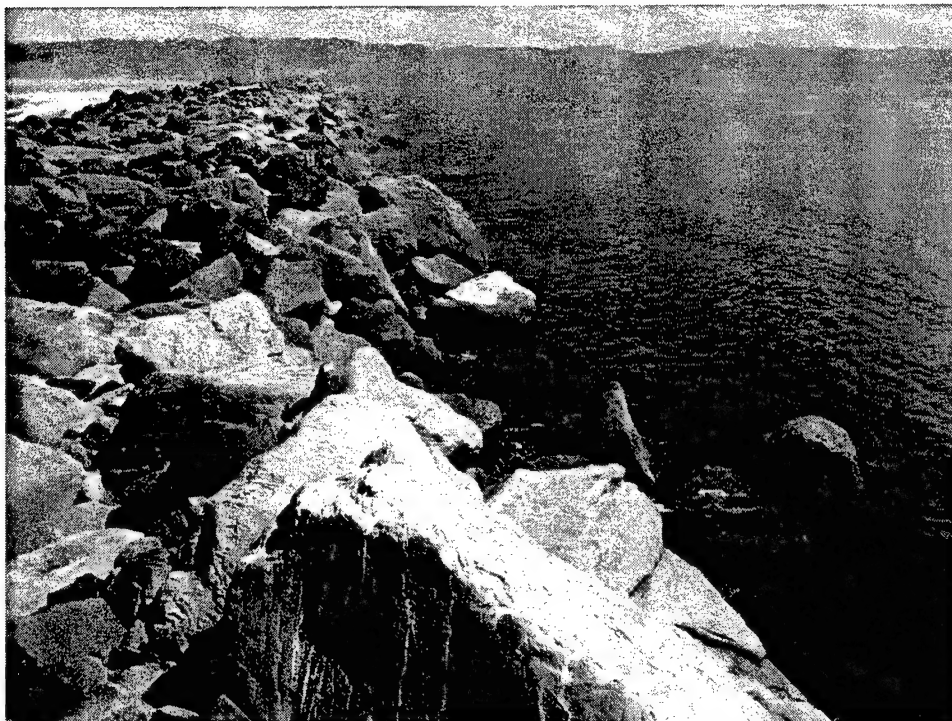
Figure 7. Void on channel side of Yaquina north jetty

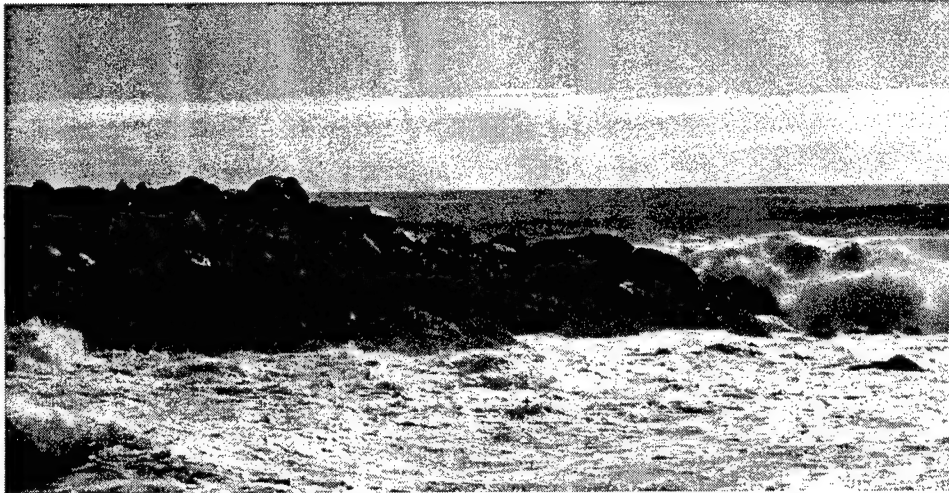
flattened slightly since the last inspection with loss of el at the tip (Figure 9). Other voids in the slopes and crests of the north jetty and north jetty spur appeared unchanged. The condition of the south jetty appeared similar to the previous inspection except the head of the south jetty spur appeared to have degraded (unraveled) slightly. The shoreward side of the spur head revealed a void and steep slope (Figure 10). Stones have been displaced and pulled down below the waterline by wave action. With the exception of the problems noted on the heads of the structures, side slopes of the structures were up to design and in good condition.

Figure 9. Photo shows loss of elevation at tip of Siuslaw north jetty head

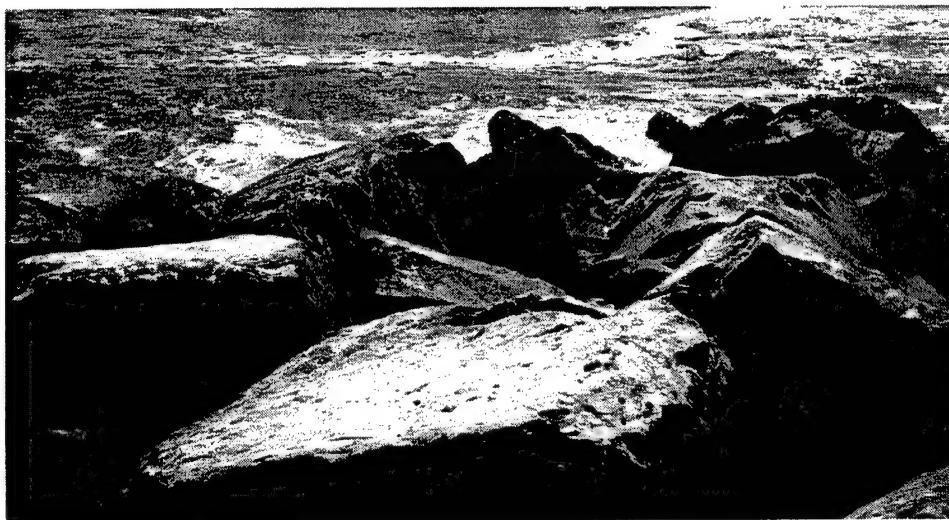
Figure 10. Area on shoreward side of Siuslaw south jetty spur head where steep slope exists

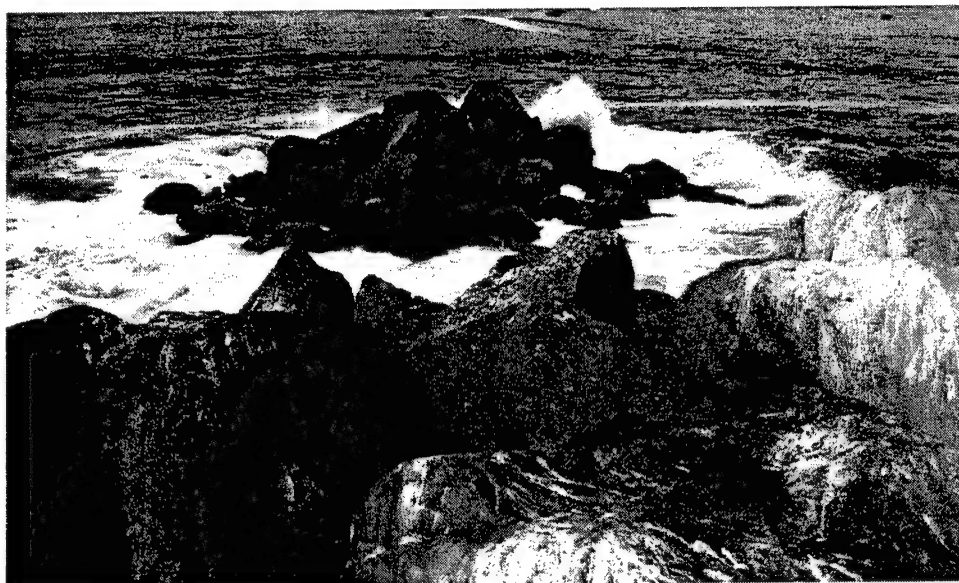
Figure 13. Breach at head of Umpqua south jetty

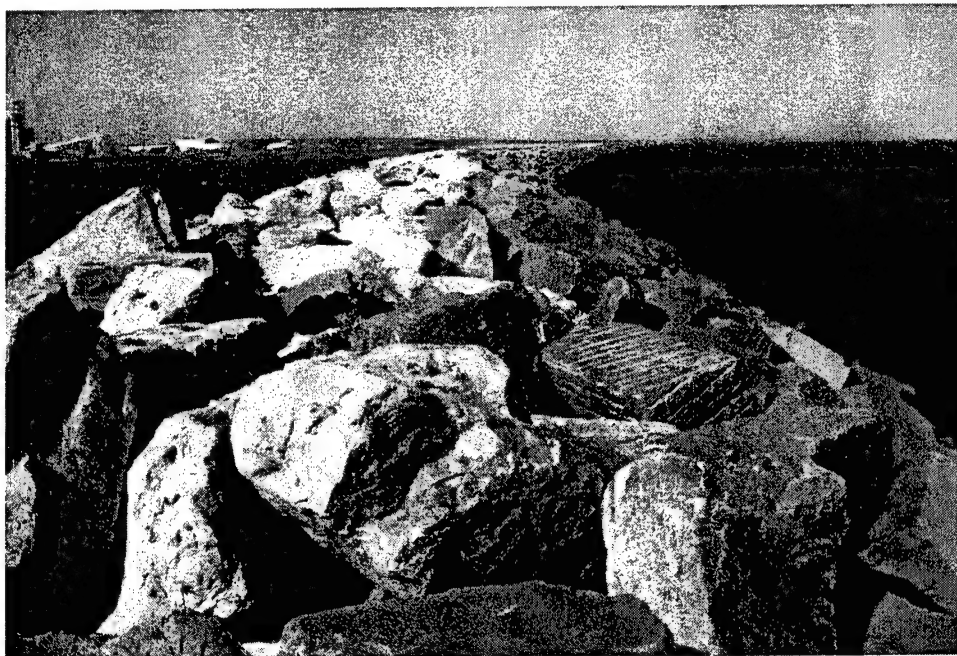
The most recent walking inspection of the Burns Harbor north breakwater (Figure 21) was conducted on 28 April 2004. Several steep areas were noted on the breakwater slopes (Figure 22). Steep slopes were observed on the harbor side of the structure at sta 8+10, 15+00, 16+10, and 17+00; and on the sea side at sta 14+70, 15+00, 25+00, 27+50, 32+30, 37+10-37+50, and 40+80. Most of these areas, however, are in reaches that were not repaired during the 1999-2003 period. A dip in the breakwater crest el was also observed between sta 25+70 and 25+90. Overall, the breakwater was functional and in good condition. Most of the recently repaired reaches were in excellent condition.

Figure 21. View of Burns Harbor breakwater in 2004 (looking west)

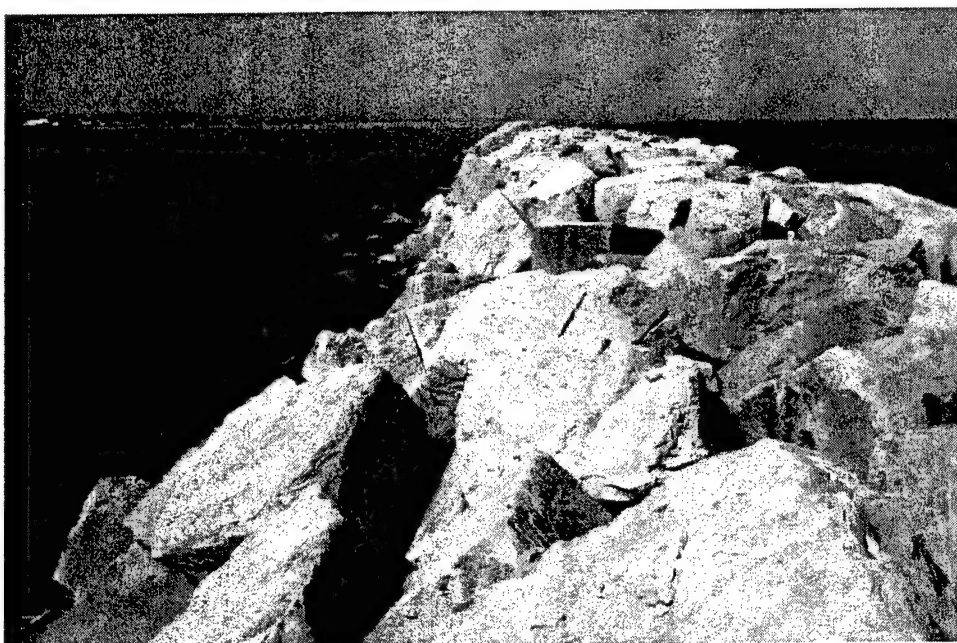
Figure 22. Steep slope on harbor side of Burns Harbor breakwater

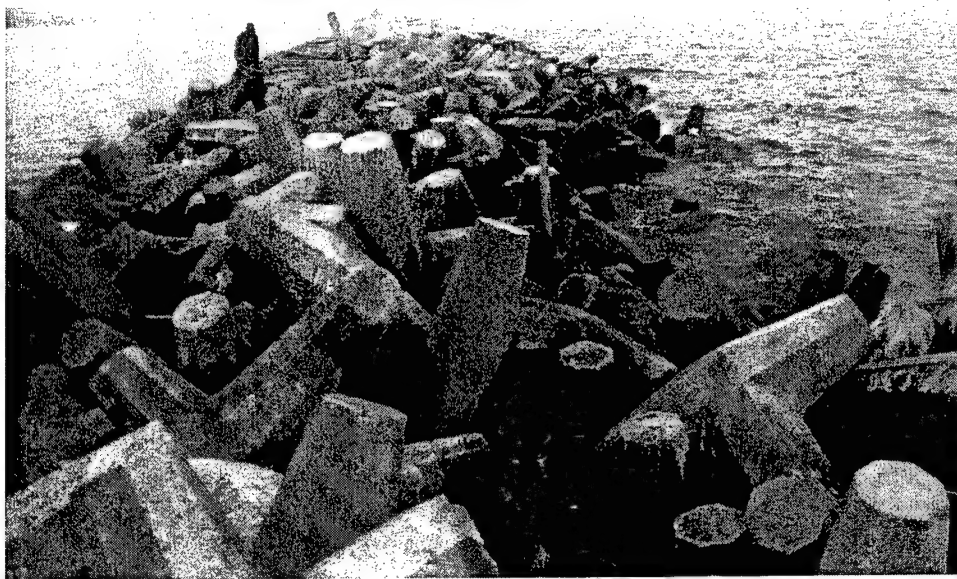
Figure 26. Void area on lakeside of Cleveland east breakwater between sta 230+40 and 230+70

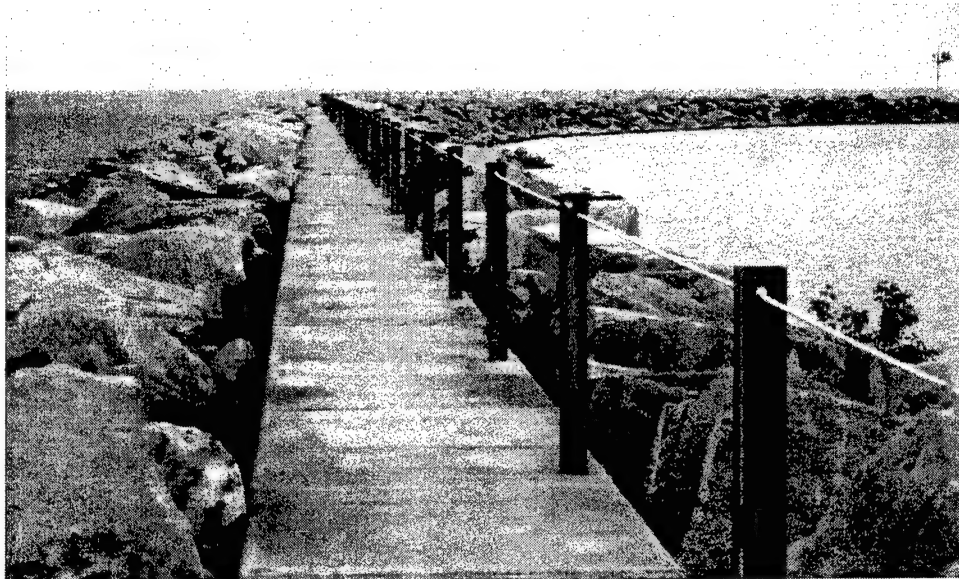
The most recent walking inspection of the Cattaraugus Creek south breakwater (Figure 28) was conducted on 20 May 2004. It was noted that the voids in the breakwater at sta 15+50 and 17+00 appeared similar to photos taken in October 1997. The void at the head, however, had degraded slightly since the previous inspection. Two additional armor stones have been displaced downslope creating a void and steep slope (Figure 29) on the southwest quadrant of the head. As noted earlier, cracked stones were observed sporadically along the structure. Overall the breakwater appeared to be functional and in good condition.

Figure 28. Cattaraugus Creek south breakwater looking lakeward

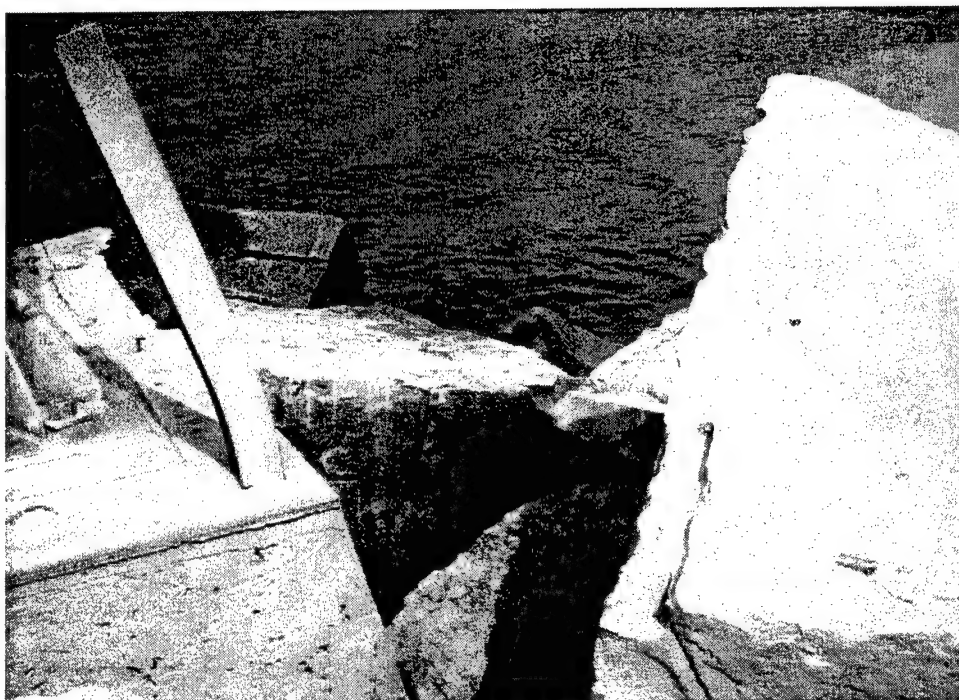
Figure 29. Void and steep slope at head of Cattaraugus Creek south breakwater

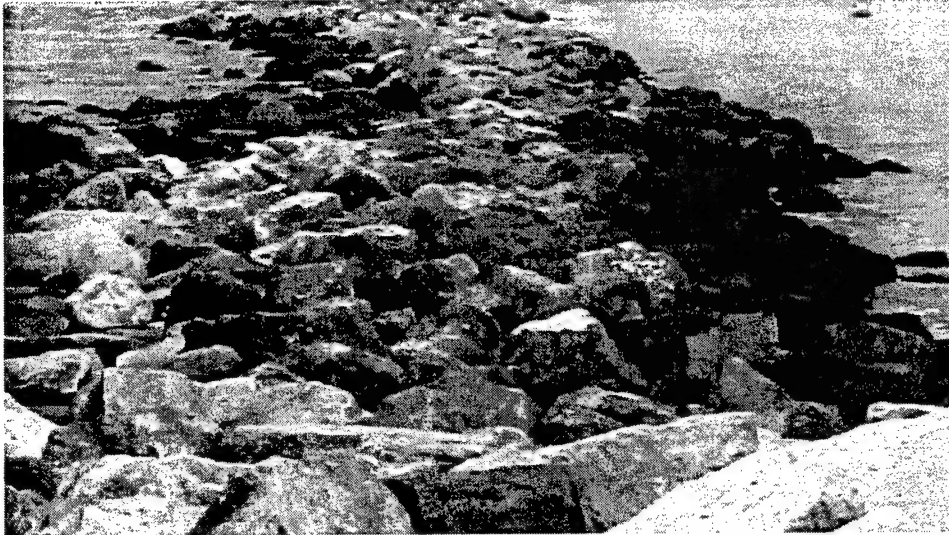
Figure 36. Seaward portion of south jetty at Ocean City inlet (beyond sta 13+00) after 2002 rehabilitation
